Item No.
 5d attach_1____

Date of Meeting
 May 28, 2013_____

Photos of Cracks and Ponding on Topping Slab

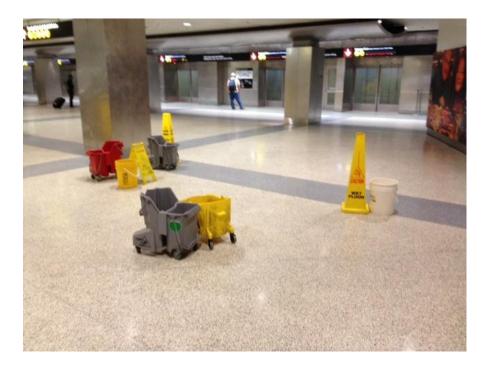
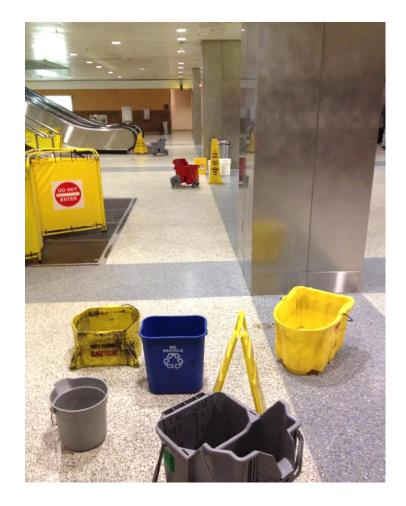
Photo of Water Leaks in the Station
