Terminal 18 Dock Rehabilitation Briefing

Date: March 11, 2014

Commission Memo

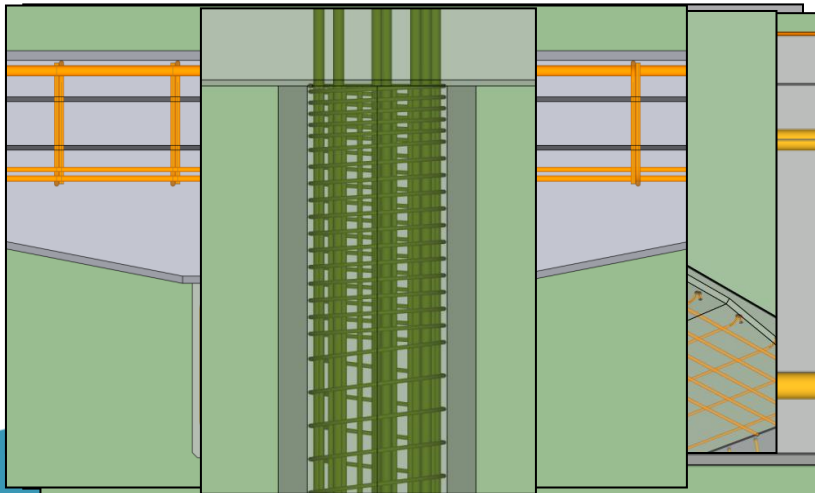
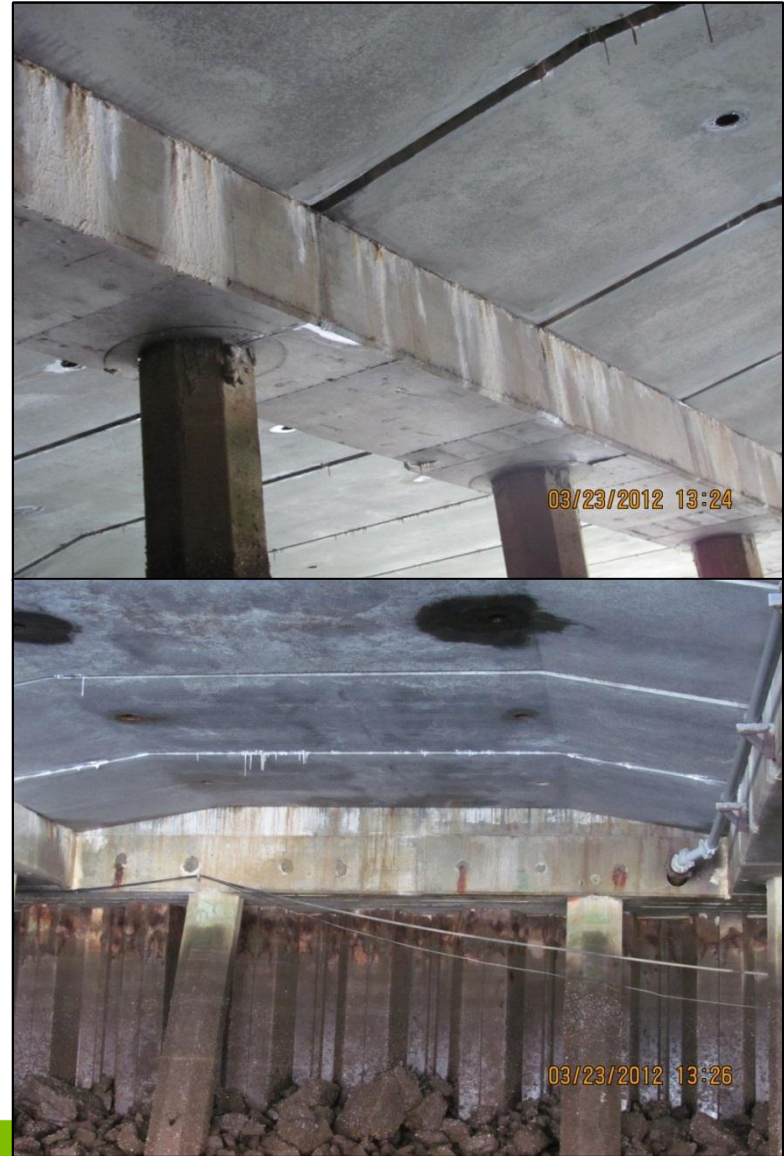
- Cracks
 - Longitudinal ←
 - Shear ←
 - Shrinkage ←
- Delamination ←
- Spalling ←
- DEF ←

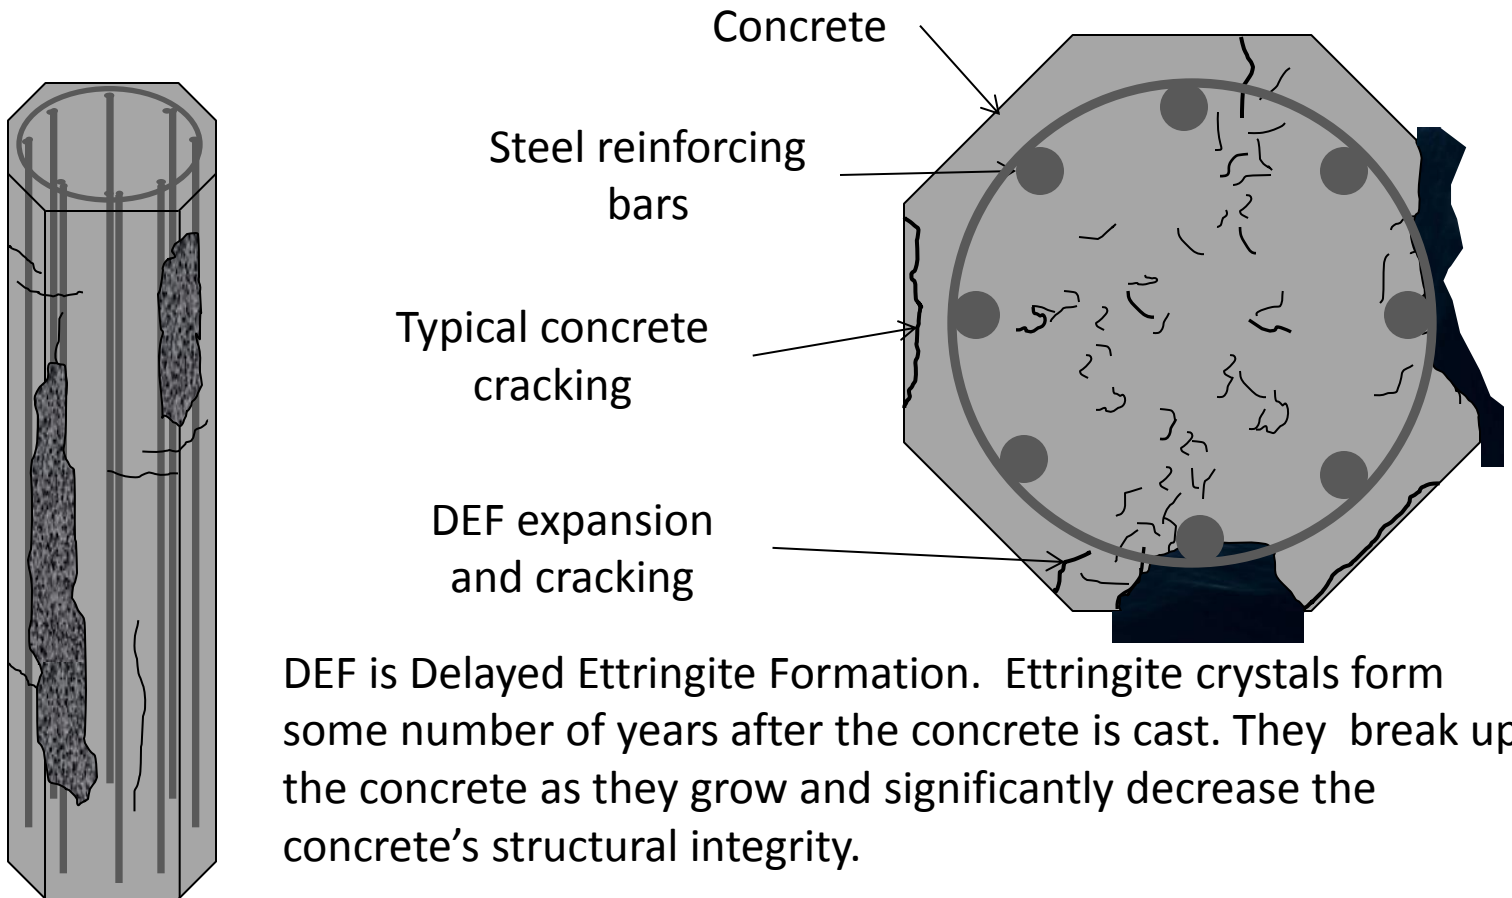
DEF in Concrete Piles

DEF is Delayed Ettringite Formation. Ettringite crystals form some number of years after the concrete is cast. They break up the concrete as they grow and significantly decrease the concrete's structural integrity.

Pile repair or replacement is necessary.

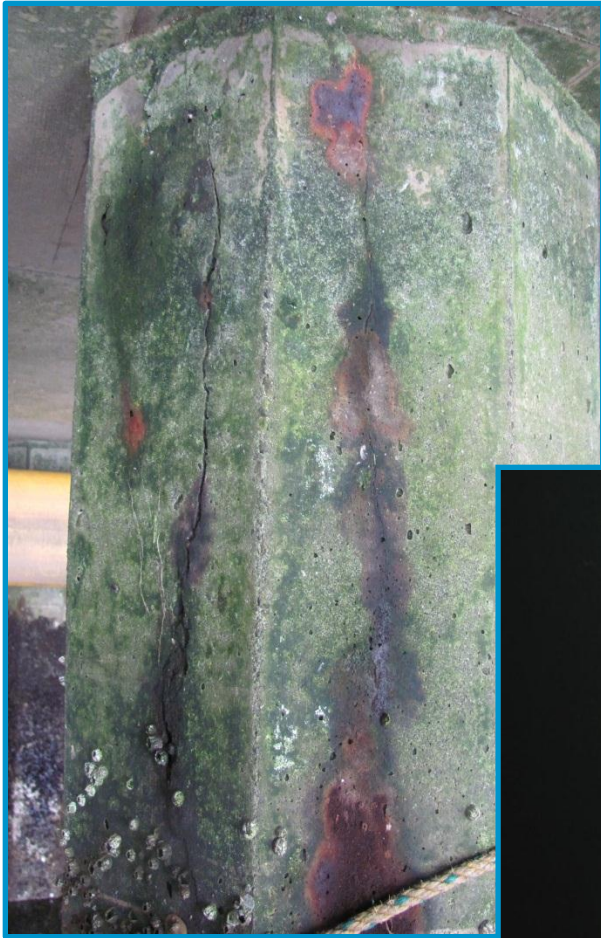
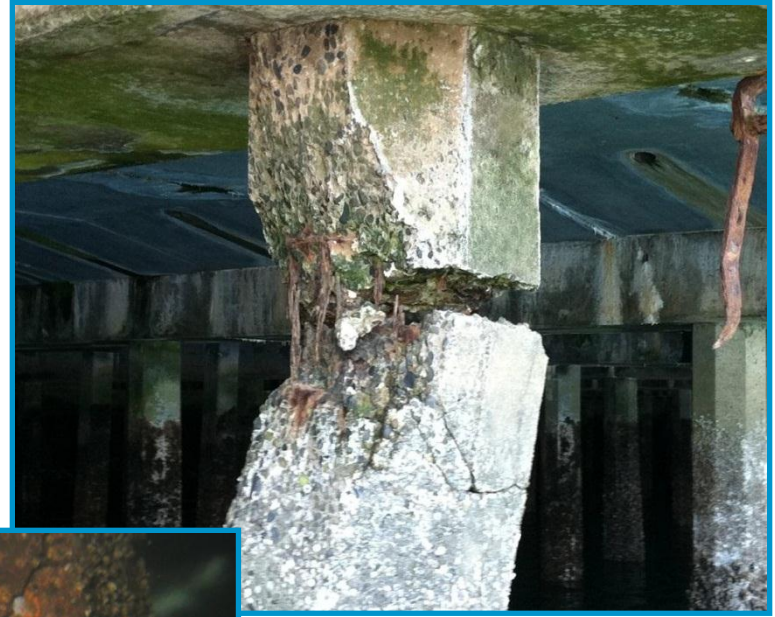
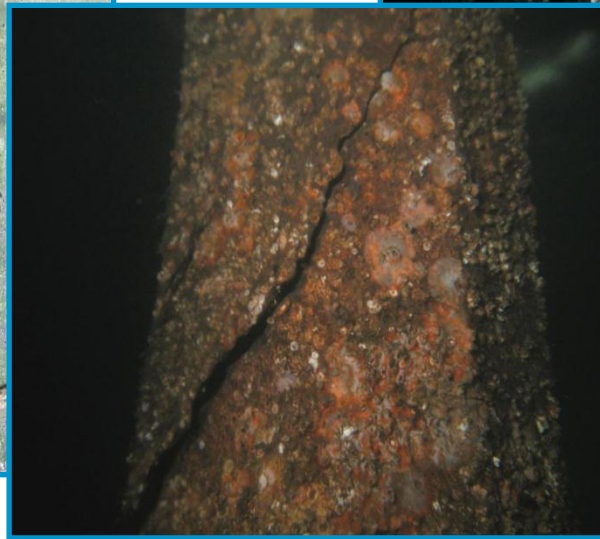
Damaged Pile examples

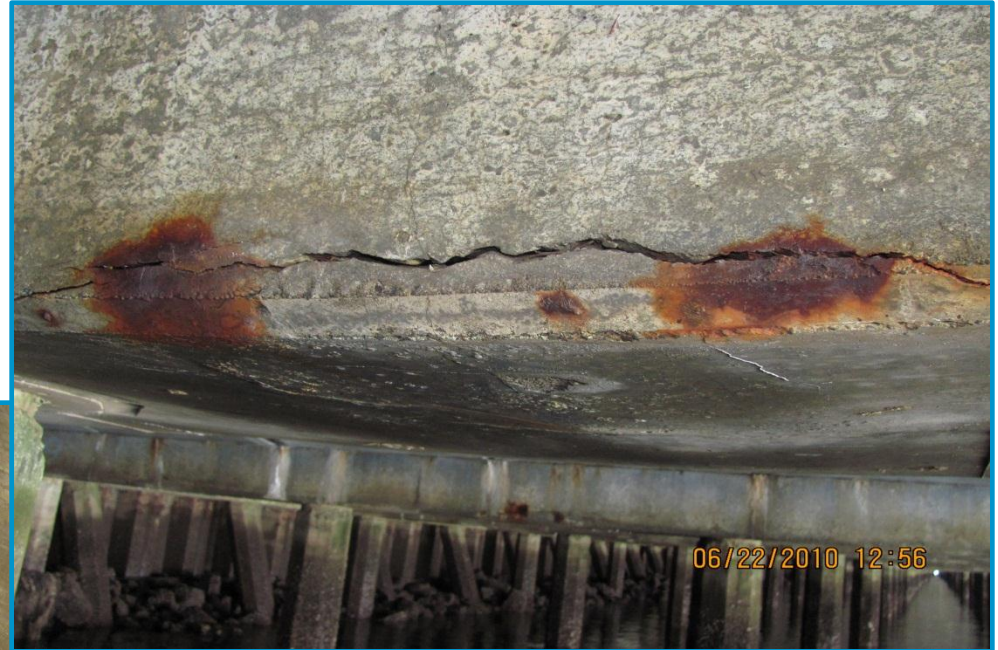
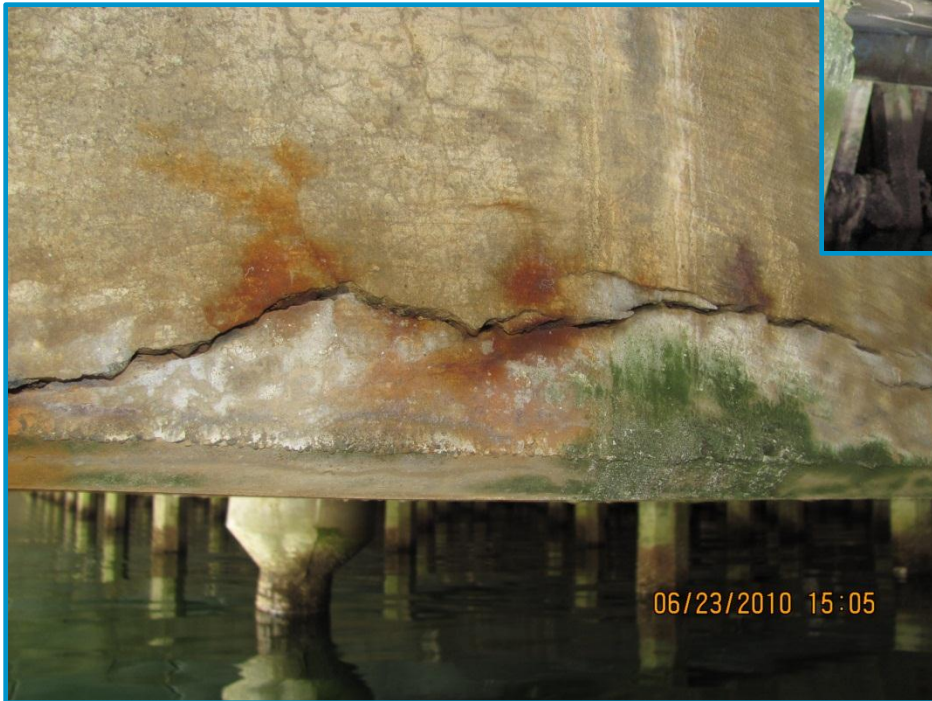
Deteriorated Pile Cap examples

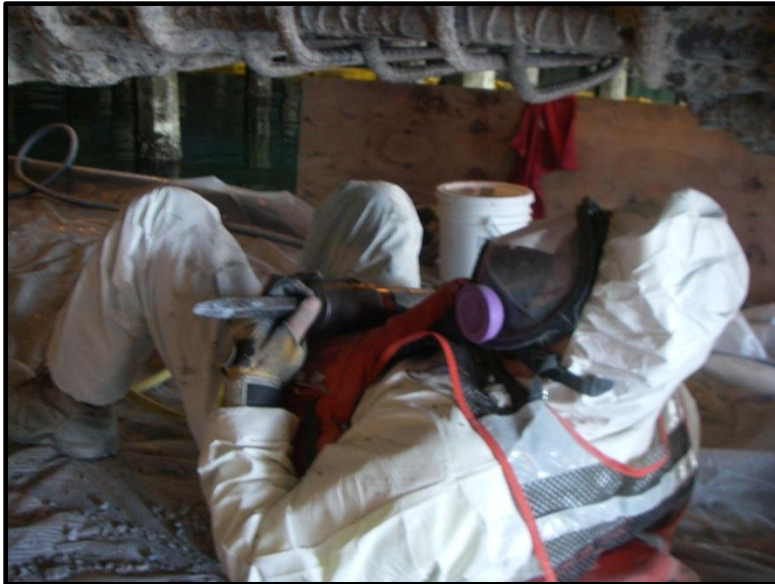
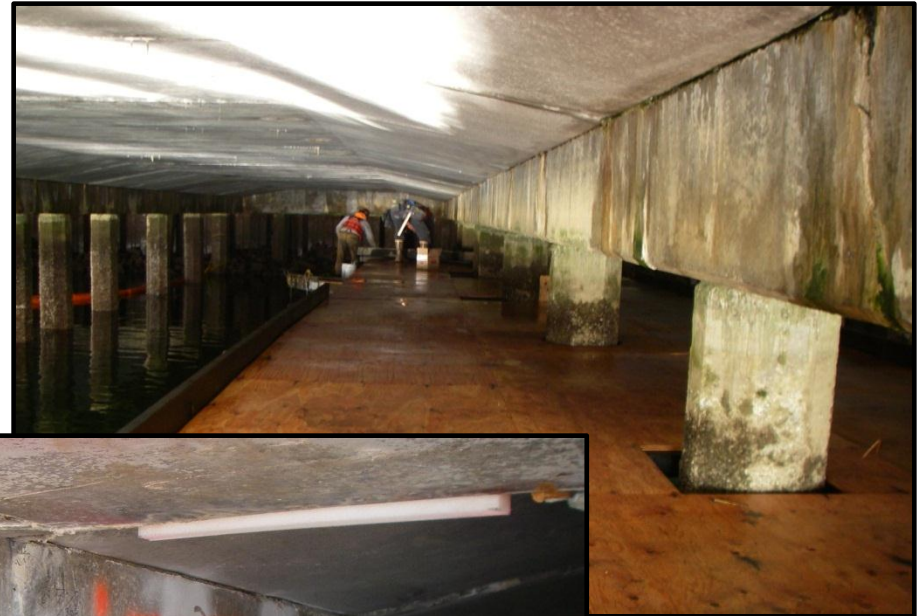
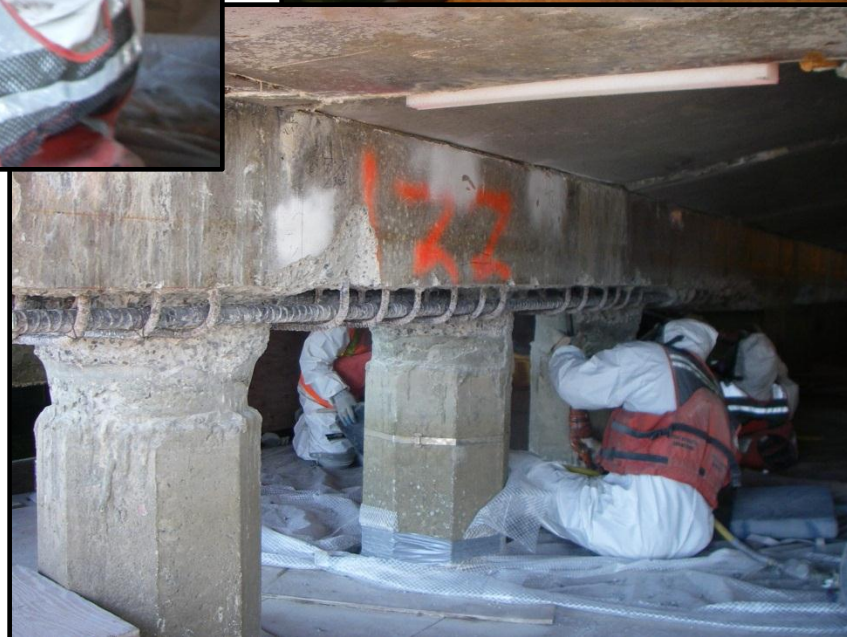
Pile Cap Repair Pictures
