Existing Site Condition Photographs:

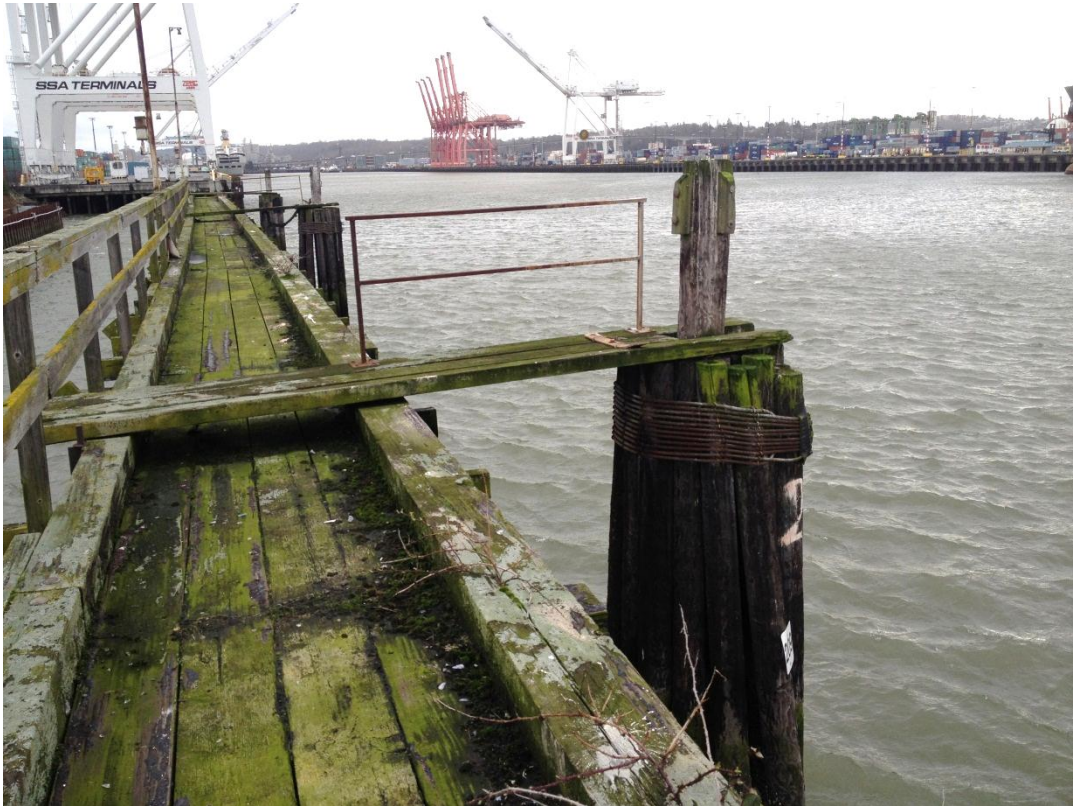
1) South end dolphins (3) and gangway, looking south

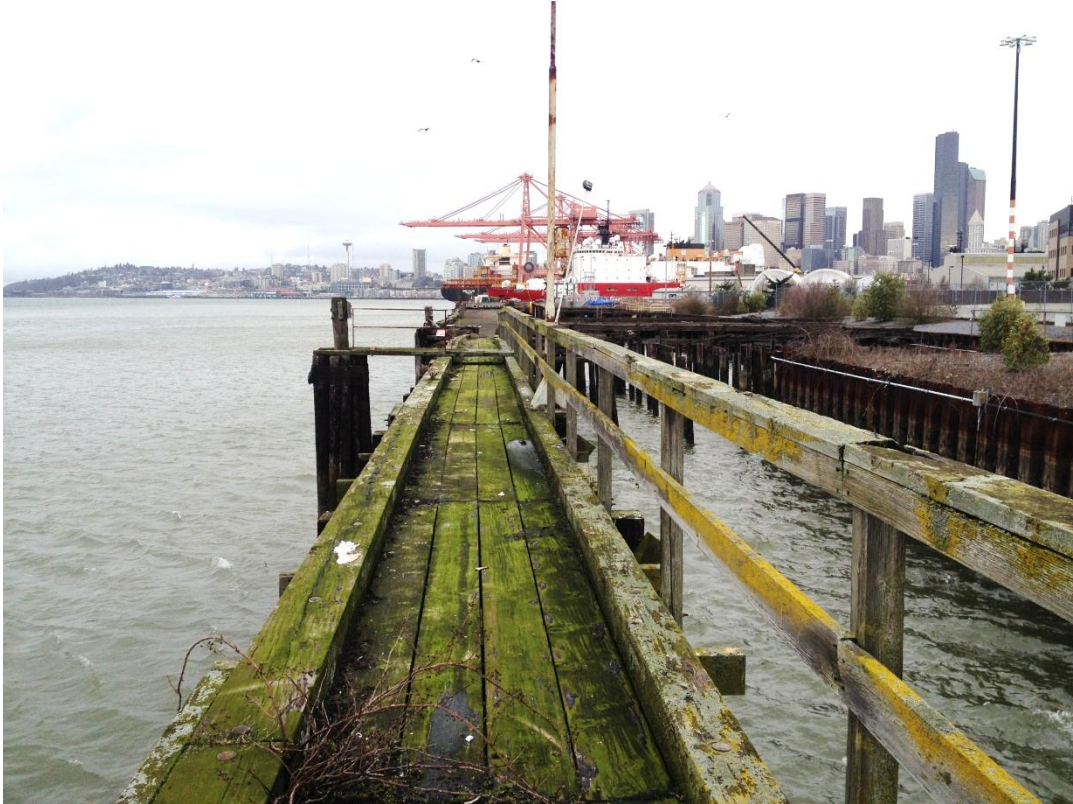
2) South end walkway looking north
