Pier 69 Roof Beam Rehabilitation (CIP #C800698)
Photos 1 Thru 6

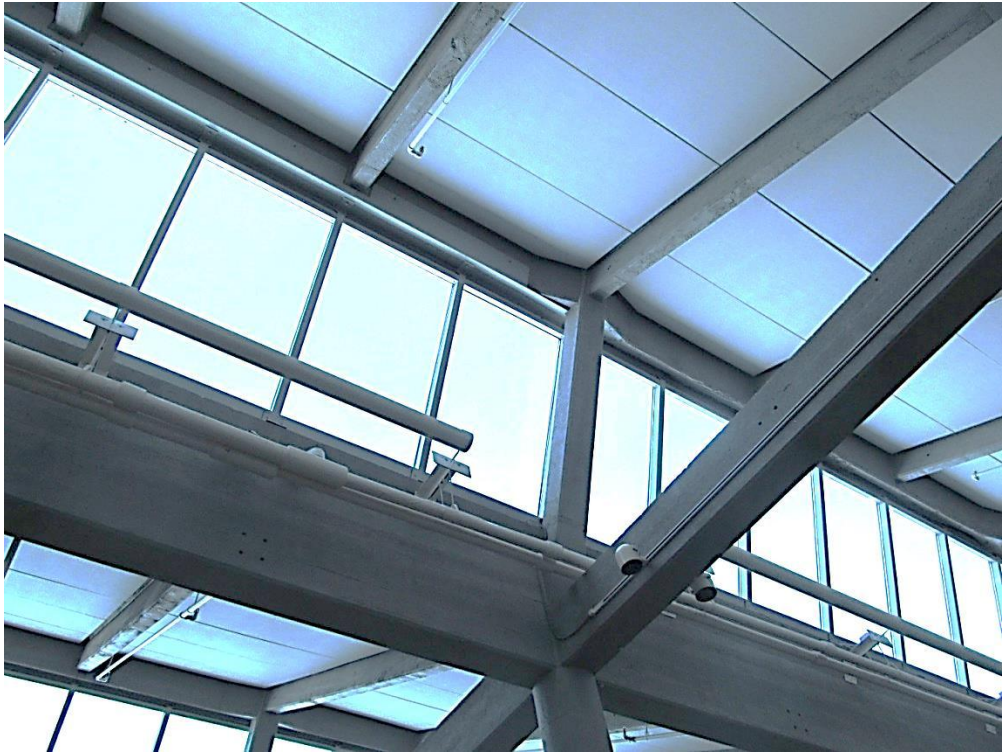
1. Atrium view of Roof Beam at top of Clerestory Window

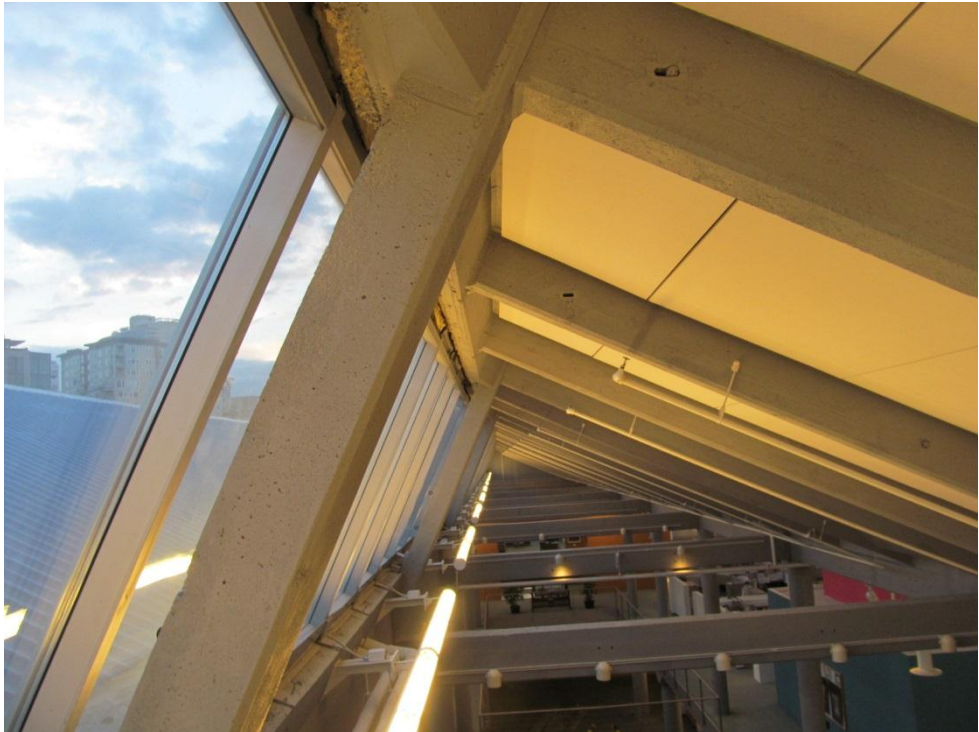
2. View Along Length of Beam

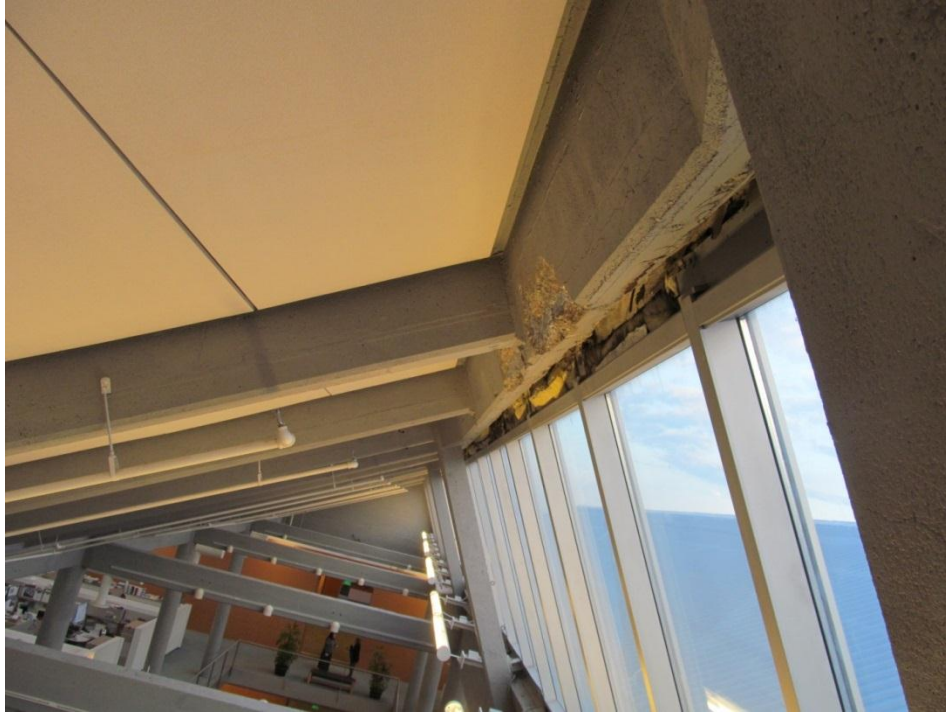
3. Example of Beam Deterioration where repair work was performed
(*loose concrete was removed and reinforcement was coated*)

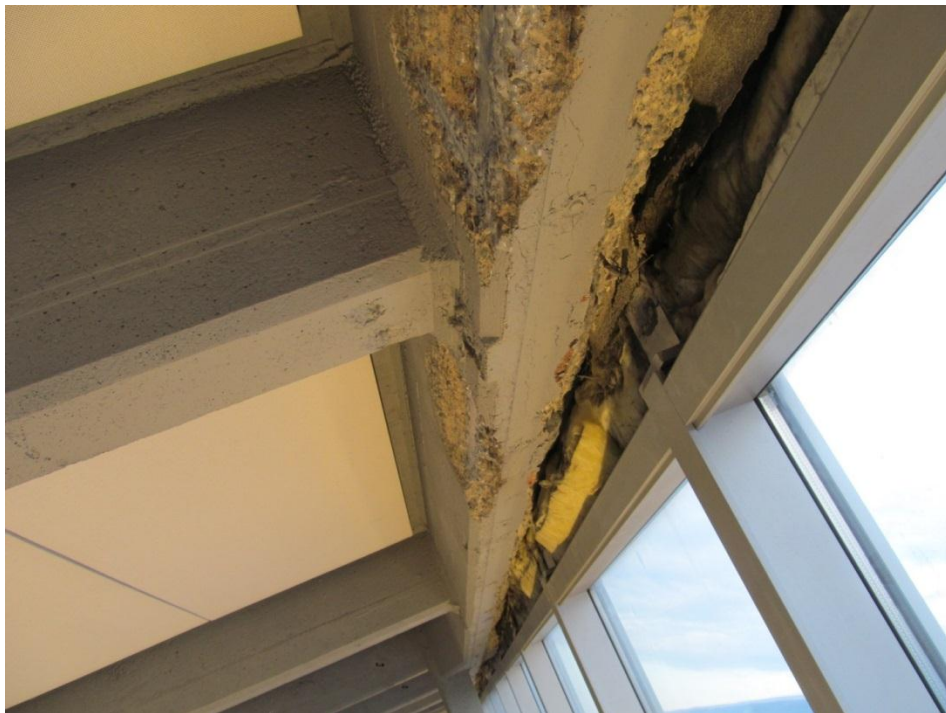
4. Close Up View

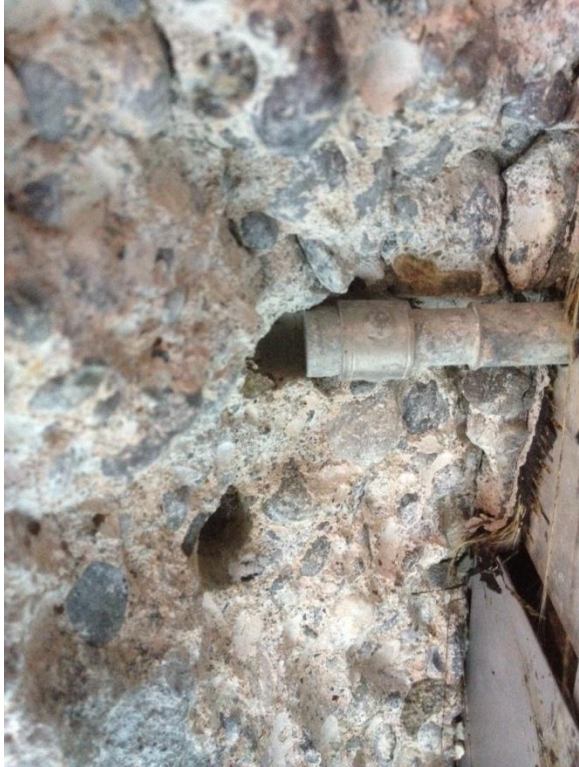
5. Exposed Window Connection Anchor Bolt

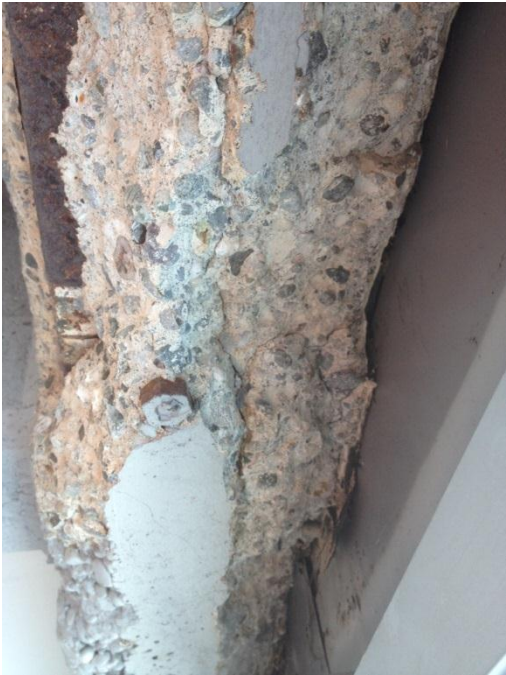
6. View of Bottom of Beam Showing Reduced Section and Exposed Reinforcement
