Item No.: 4d_Supp Date: September 13, 2016

Terminal 91 Building C-173 Roof Overlay

Building C-173 Roof Overlay

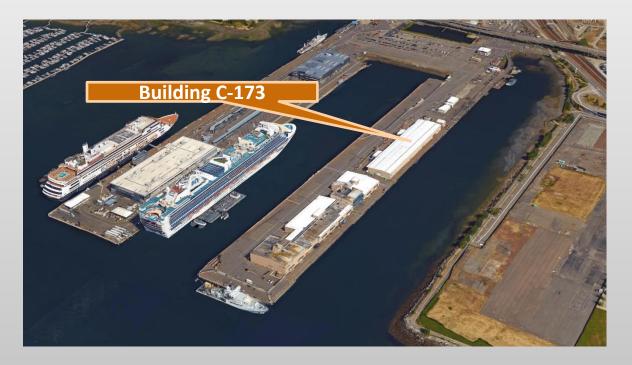
Existing C-173 Roof Approximately 29 Years Old
