TERMINAL 108 – ENVIRONMENTAL CONDITIONS REPORT

FINAL

January 23, 2009

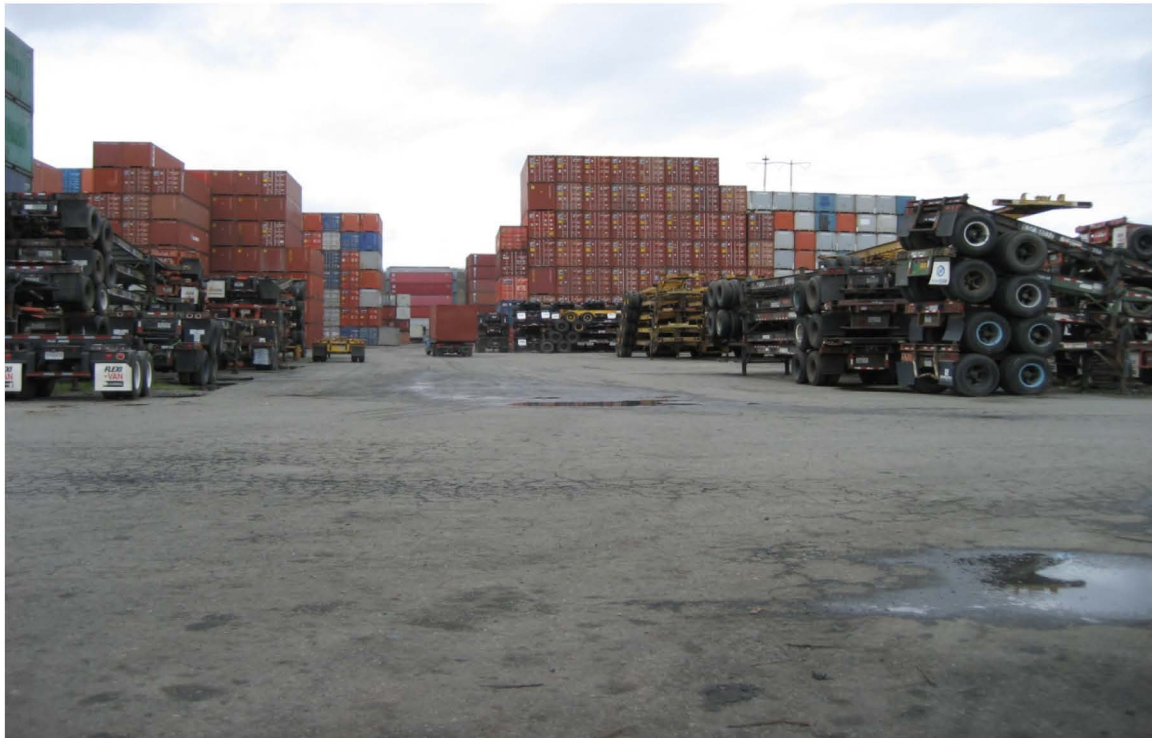
Photo 1: ConGlobal Industries container terminal operations on the eastern parcel of T-108.

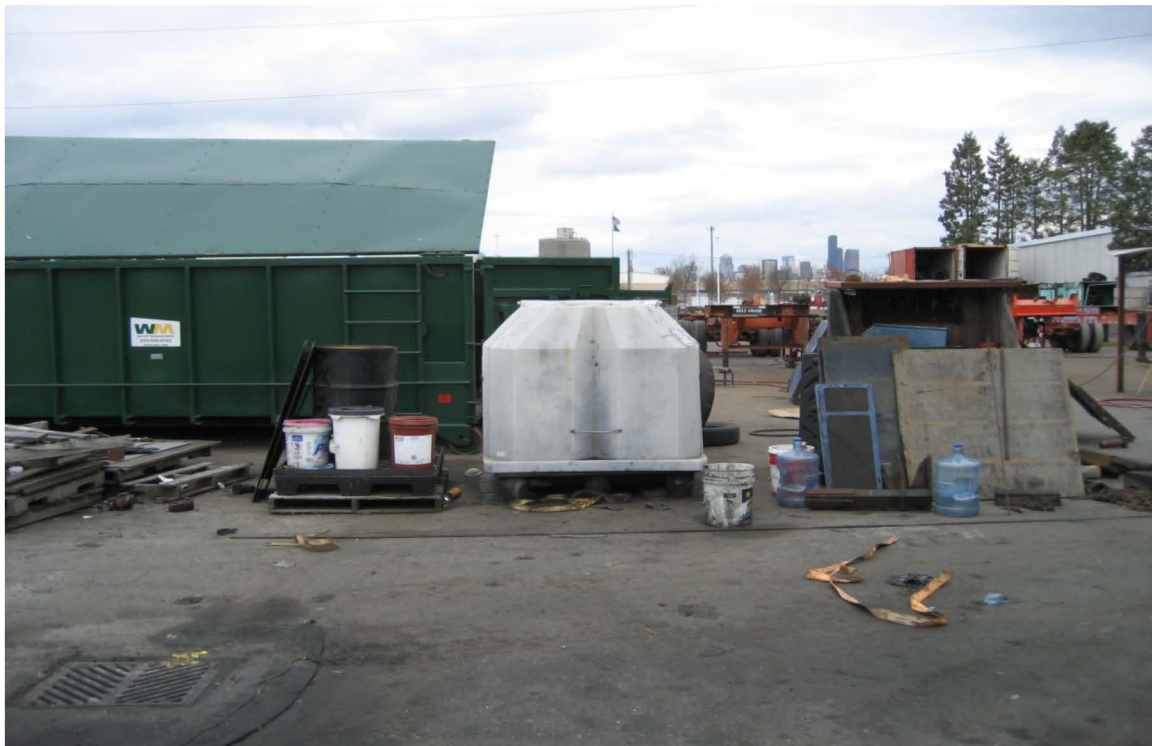
Photo 2: View (looking north) of the maintenance area located on the eastern portion of the ConGlobal Industries container terminal.

ConGlobal is currently the only tenant at T-108, and the company continues to operate a container terminal on the Eastern Parcel. Containers are stored throughout the Eastern Parcel and maintenance is conducted on the eastern end of the parcel (Appendix A, Photo 2). A fueling area, which includes two aboveground storage tanks (AST) containing diesel (one 300-gallons and one 600-gallons) is located on the southern portion of the Eastern Parcel. An additional 1,200-gallon AST is also located in this area.

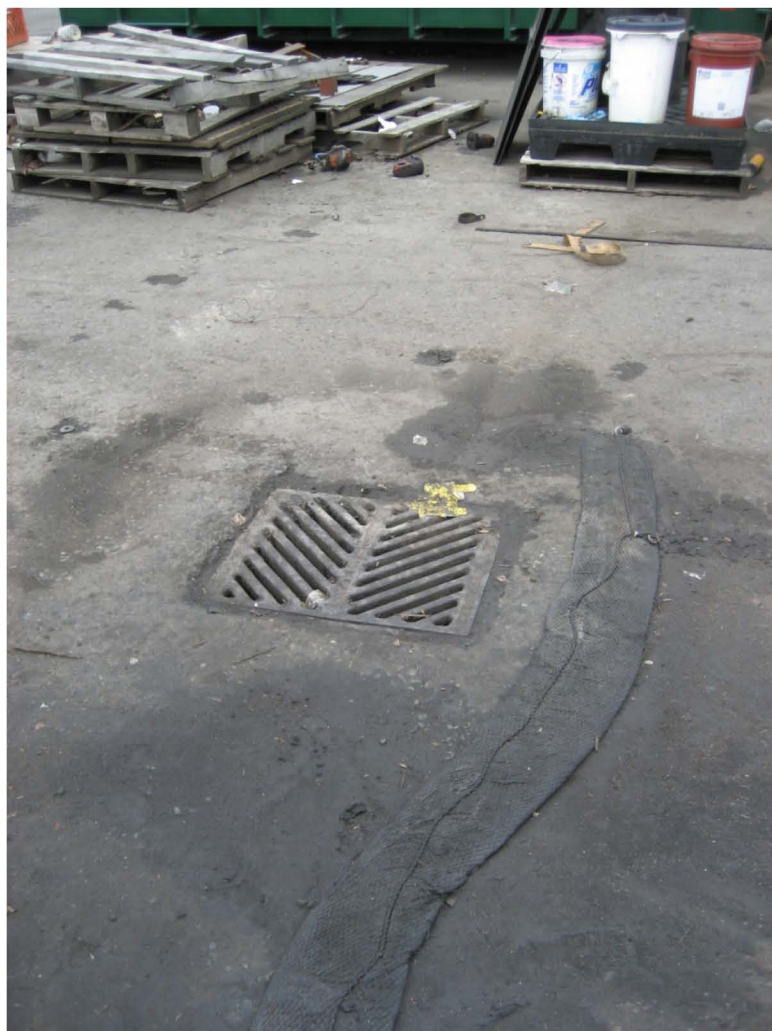
Photo 3: A catch basin on the northern portion of the ConGlobal Industries container terminal located near the maintenance area (eastern parcel).

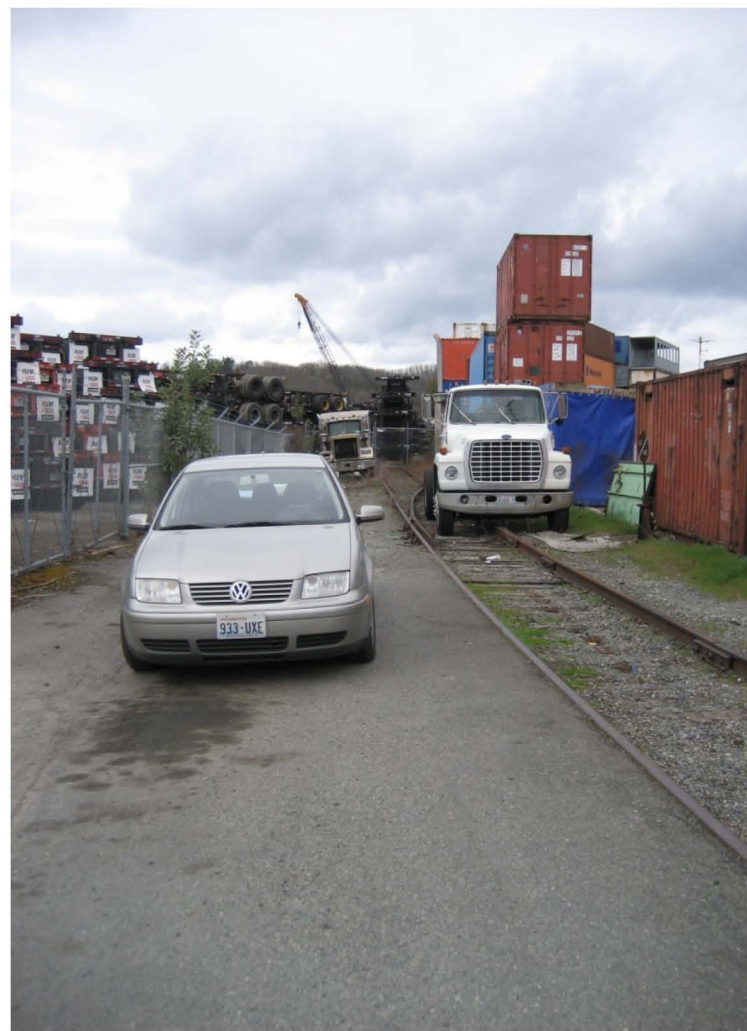
Photo 4: View (looking northwest from Diagonal Ave S) of the railway crossing the southern portion of the eastern parcel onto the eastern and central portions of the western parcel of T-108.

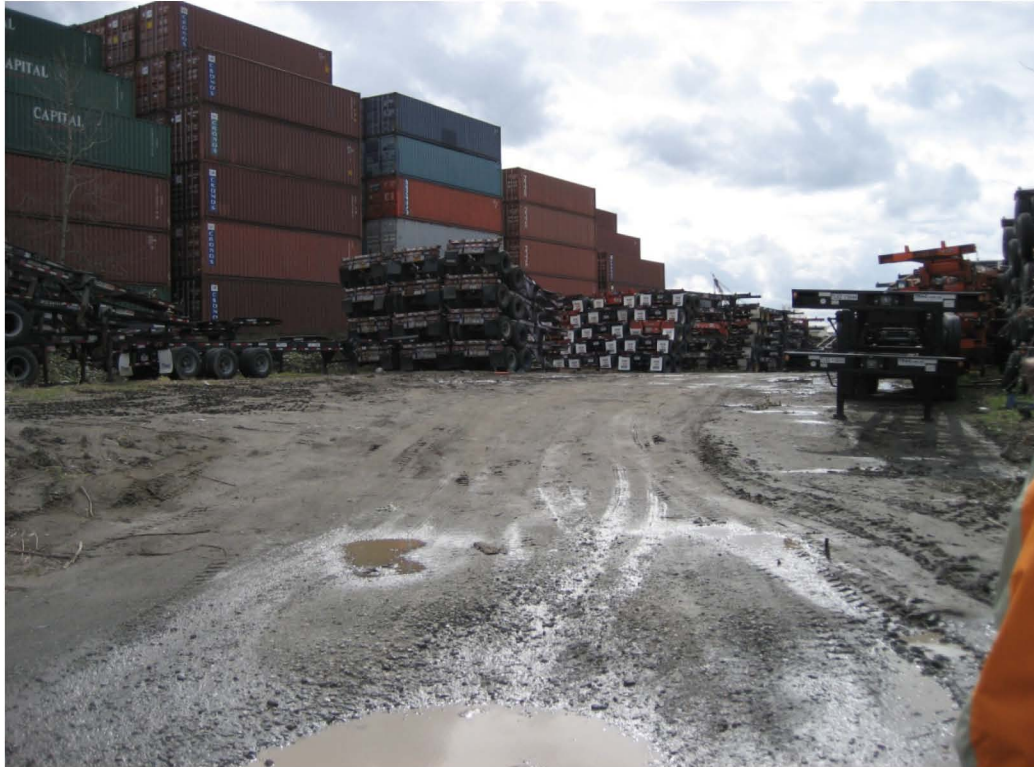
Photo 5: View (looking south) of the northern portion of the western parcel of T-108. Container chassis are stored on portions of this parcel. The containers in the background are located on the eastern parcel.

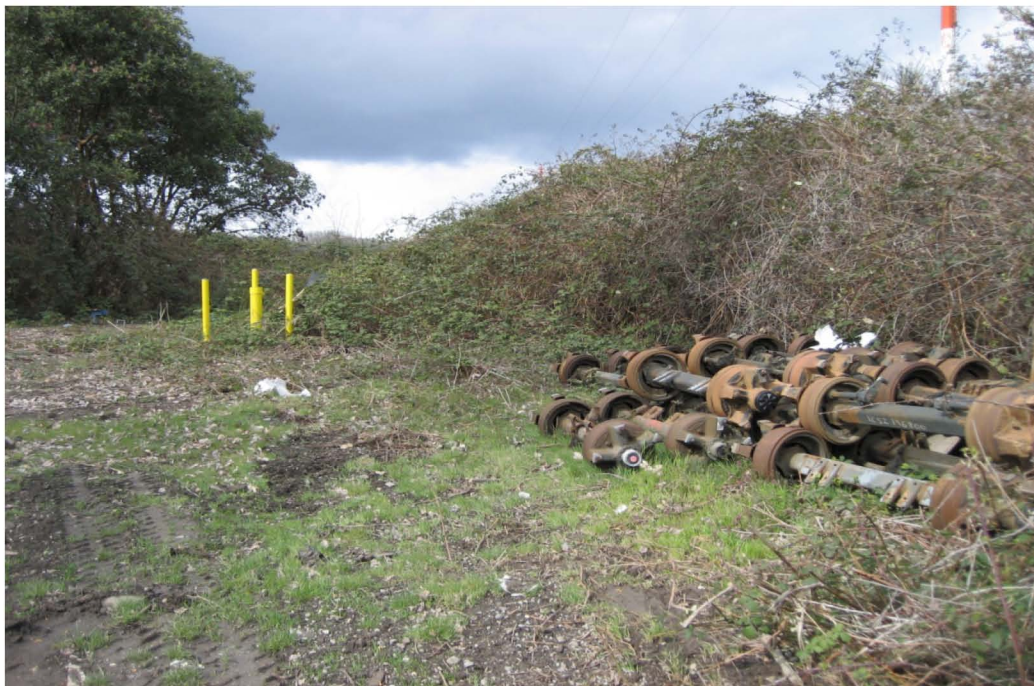
Photo 6: Vegetation, chassis parts storage, and a groundwater monitoring well (PGG-5) located on the northern portion of the western parcel of T-108.

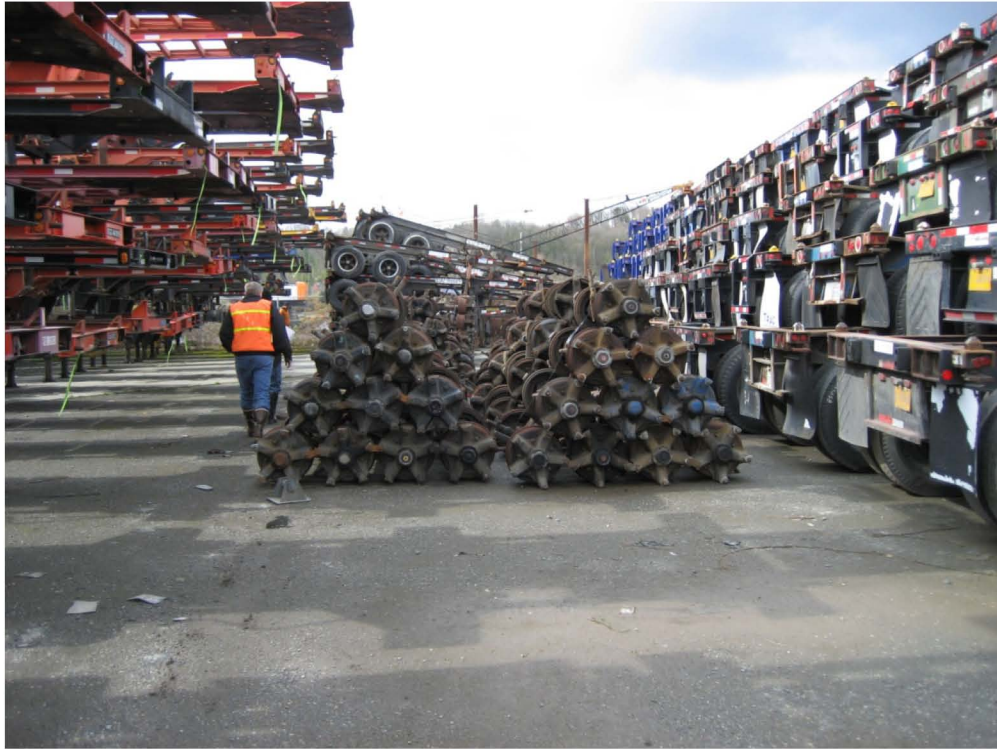
Photo 7: View (looking west) of the chassis storage area located on the paved, central portion of the western parcel of T-108.

ConGlobal also leases the majority of the Western Parcel for use as a chassis storage and lay-down area (Appendix A, Photos 7 and 8). The public access park and mitigation area remain on the southern portion of the Western Parcel and are not included in the ConGlobal lease area (Appendix A, Photos 9 and 10). For reference purposes, Map 8 provides a comprehensive presentation of the historical site features (presented on Maps 6 and 7) overlying the current conditions of the T-108 subject property. Map 9 expands this comprehensive presentation to include the locations of previous soil and groundwater sample locations.

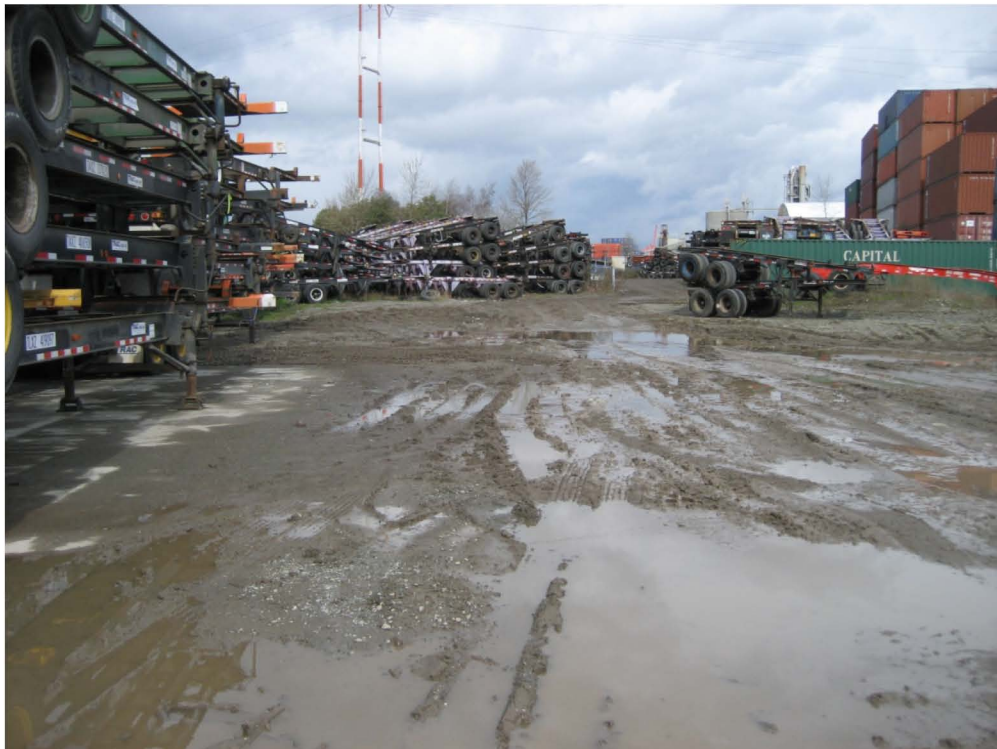
Photo 8: View (looking north) from the interior of the western parcel of T-108. High-power transmission lines located along the S Oregon St ROW are visible in the background.

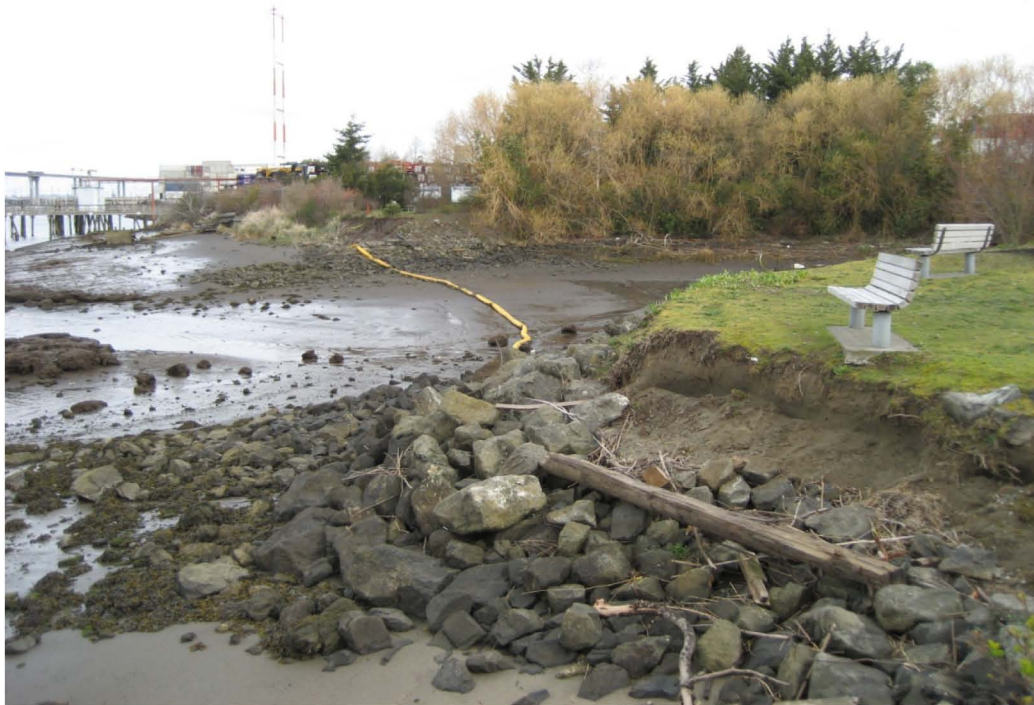
Photo 9: View (looking north from the Diagonal Ave S street-end) of the T-108 mitigation area and shoreline; protective buoy line visible at center of image.

buffer surrounds a U-shaped mudflat area that extends into the LDW (Appendix A, Photos 9 and 10). A buoy line is present along the mouth of the mitigation area to prevent debris from washing into the site. Vegetation within the public access and mitigation area is routinely maintained by Port maintenance crews and appears to be healthy, and the area provides fish and wildlife habitat. The public access area extends to a public parking area located at the end of Diagonal Avenue S which also includes a lawn area, picnic tables, a launch for hand-carried boats, and interpretive signage. Existing trees on the eastern perimeter of the public access area provide visual screening from the rest of T-108 and E Marginal Way S (Appendix A, Photo 9).

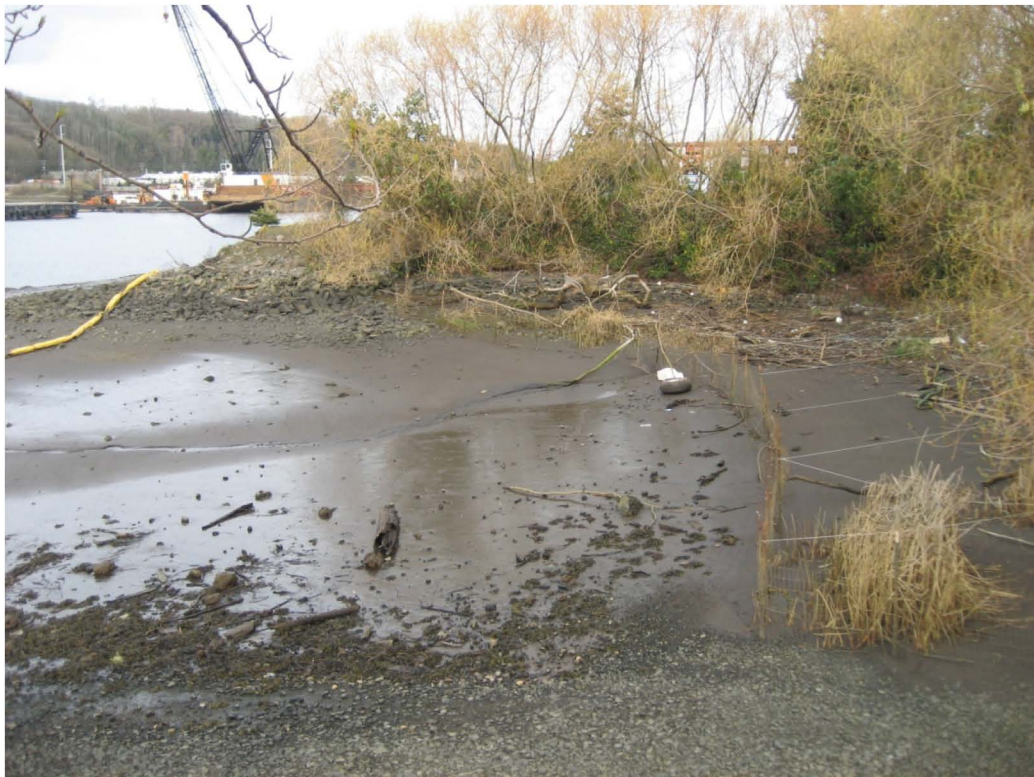
Photo 10: Close-up view (looking north) of the T-108 mitigation area.

The T-108 shoreline is approximately 1,200 ft (or 0.23 mi) long. The bank elevation of the northern and central portions of the shoreline varies from 0 to 10 ft (Port of Seattle Datum) (Port of Seattle 1993). The bank elevation of the southern portion of the shoreline, which includes the mitigation area, varies from approximately 4 to 18 ft (Port of Seattle Datum). The northern and central portions of the T-108 shoreline are armored with riprap, gravel, and other materials (Appendix A, Photo 15). Along the south-central portion of the shoreline, to the north of the mitigation area, the shoreline is partially armored with riprap and a wooden bulkhead which runs parallel to the shoreline. The bulkhead is not well-anchored and is slanted away from the shoreline (Appendix A, Photos 12 and 13). Within the park and mitigation area, the T-108 shoreline is primarily unarmored, with the exception of gravel (habitat mix) scattered along the perimeter (Appendix A, Photo 10).

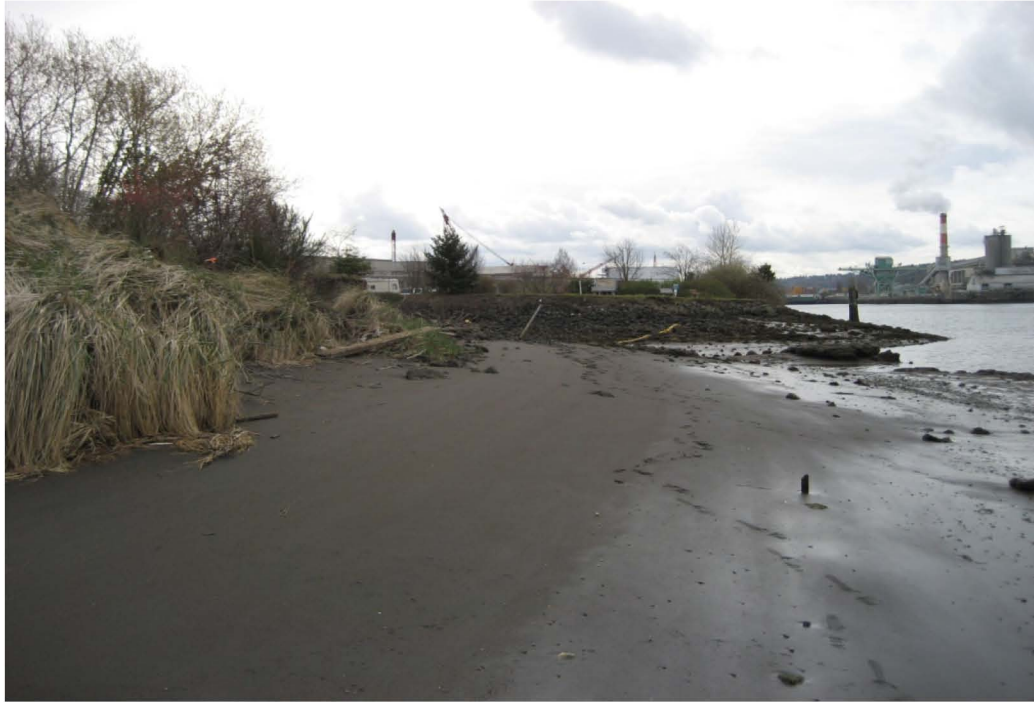
Photo 11: View (looking south toward the mitigation area) of the southern portion of the T-108 shoreline.

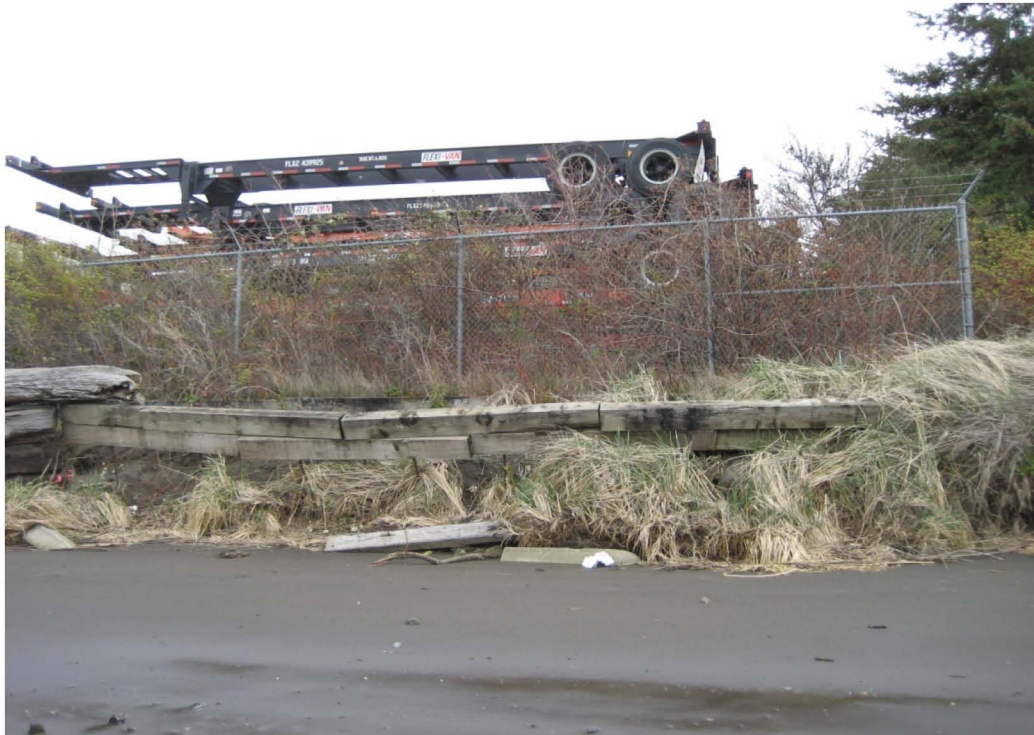
Photo 12: A portion of the wooden bulkhead located on the south-central portion of the T-108 shoreline.

accordance with the Port's public access plan (Port of Seattle 1985a) and included a trail and hand-boat launch area. The wooden bulkhead observed along the property shoreline in March 2008 were associated with the public access trail (Blomberg 2008) (Appendix A, Photos 12 and 13).

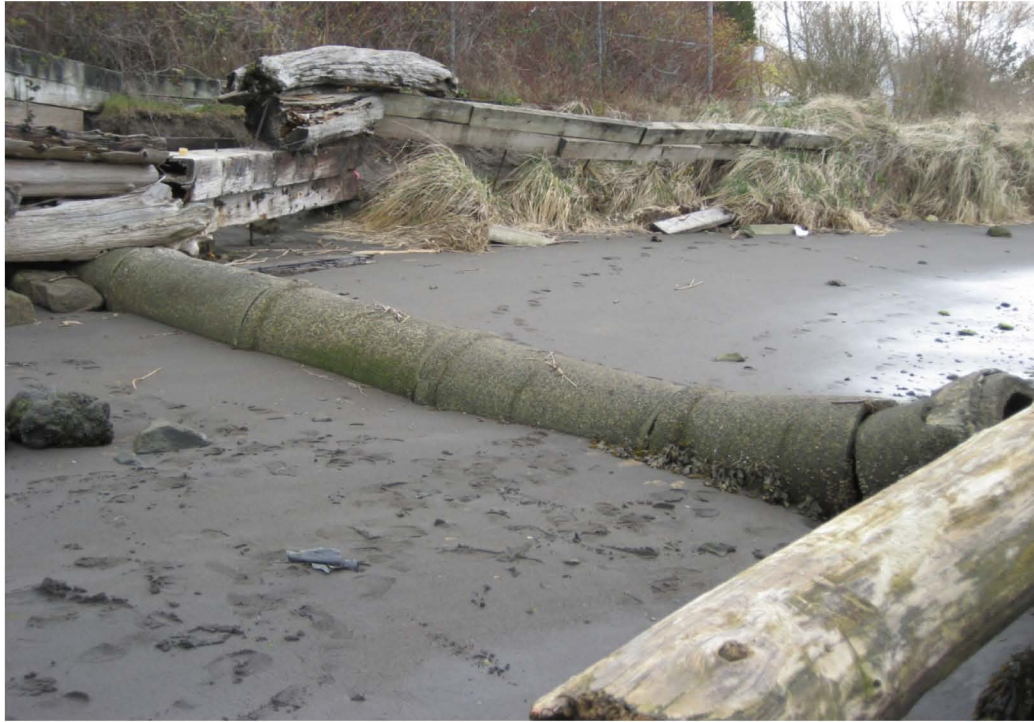
Photo 13: Wooden bulkhead and the Port storm drain outfall (2225) located on the south-central portion of the T-108 shoreline.

Two outfalls points are located along the T-108 shoreline boundary. One is an active storm drain outfall that drains the southern portion of the Western Parcel (Port of Seattle outfall 2225 on Map 2), located in the vicinity of the wooden bulkhead (Appendix A, Photo 13). The second is an abandoned outfall formerly associated with the Diagonal Avenue S STP, located to the north of the active outfall (former Diagonal Avenue S STP outfall 2002 on Map 2; Appendix A, Photo 14). In addition, a wooden box frame structure in an extreme state of disrepair was observed in approximately the middle of the shoreline. The former purpose of this structure is not known.

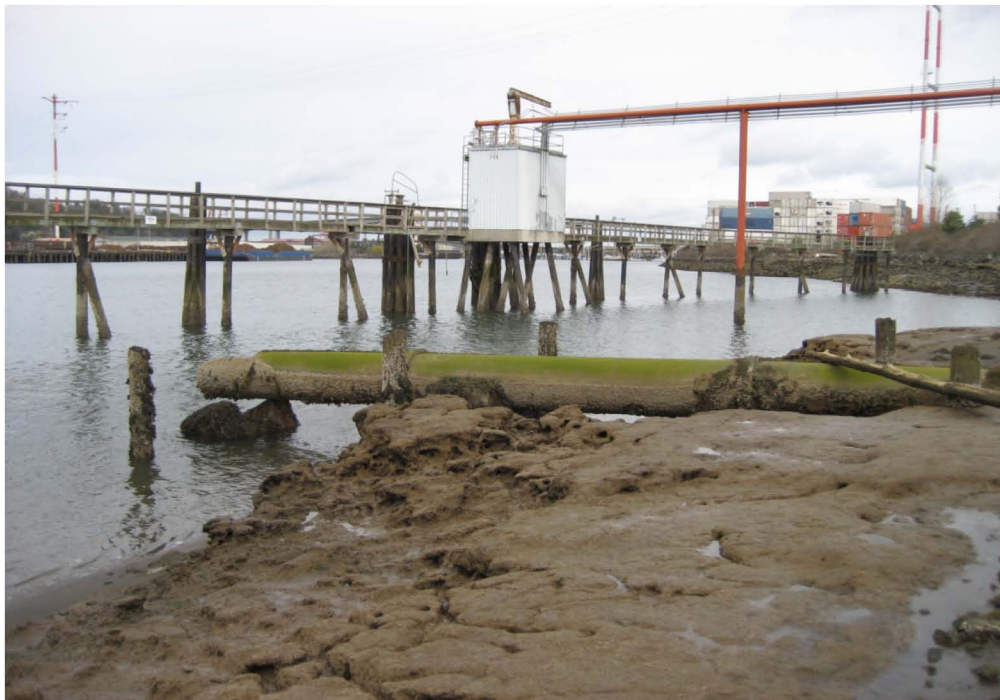
Photo 14: View (looking northwest) of the abandoned Diagonal Ave STP outfall and the pipeline dock (installed by Lafarge) located on the north-central portion of the T-108 shoreline. Note the native intertidal substrate.

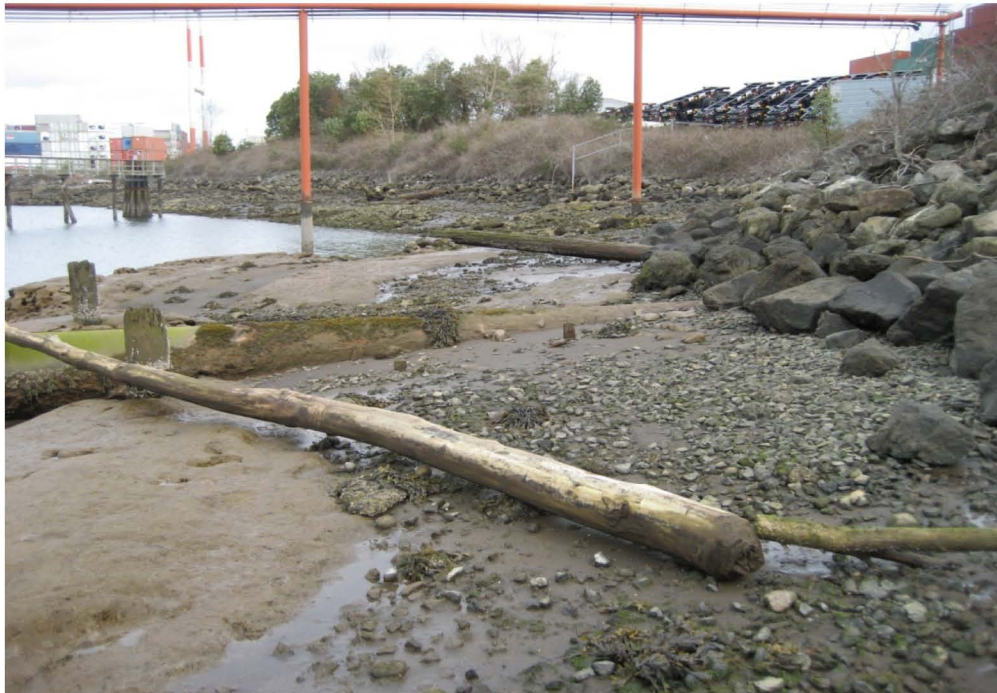
Photo 15: View (looking north) of the north-central and northern portions of the T-108 shoreline; the bank in this area is armored with rip-rap.

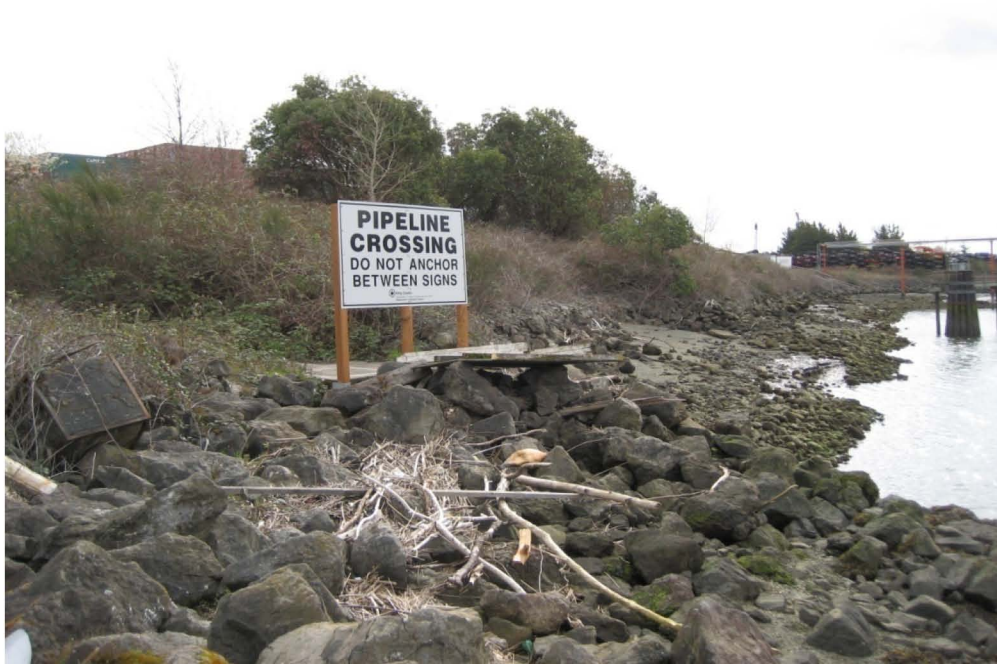
Photo 16: View (looking south from the S Oregon St ROW end) of the northern portion of the T-108 shoreline. The Duwamish/Diagonal CSO/SD and EOF outfalls are nearby, and the location of the Duwamish Siphon is indicated by the sign.

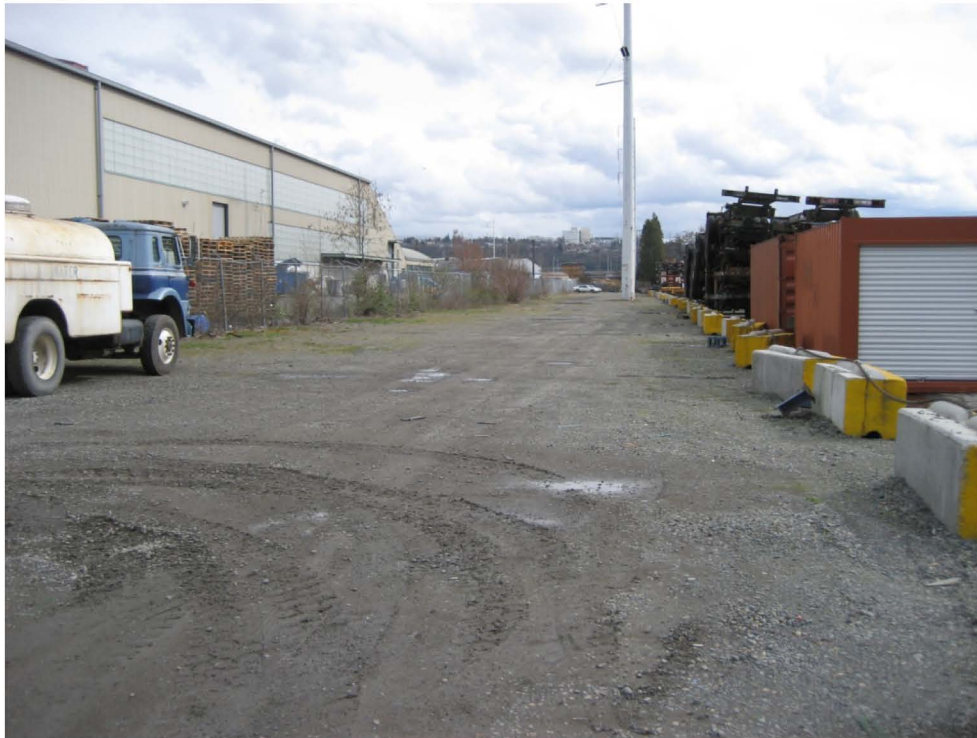
Photo 17: View (looking east) of the S Oregon St ROW. T-108 is on the right-hand side of the photograph, and the WSLCB property is to the left.

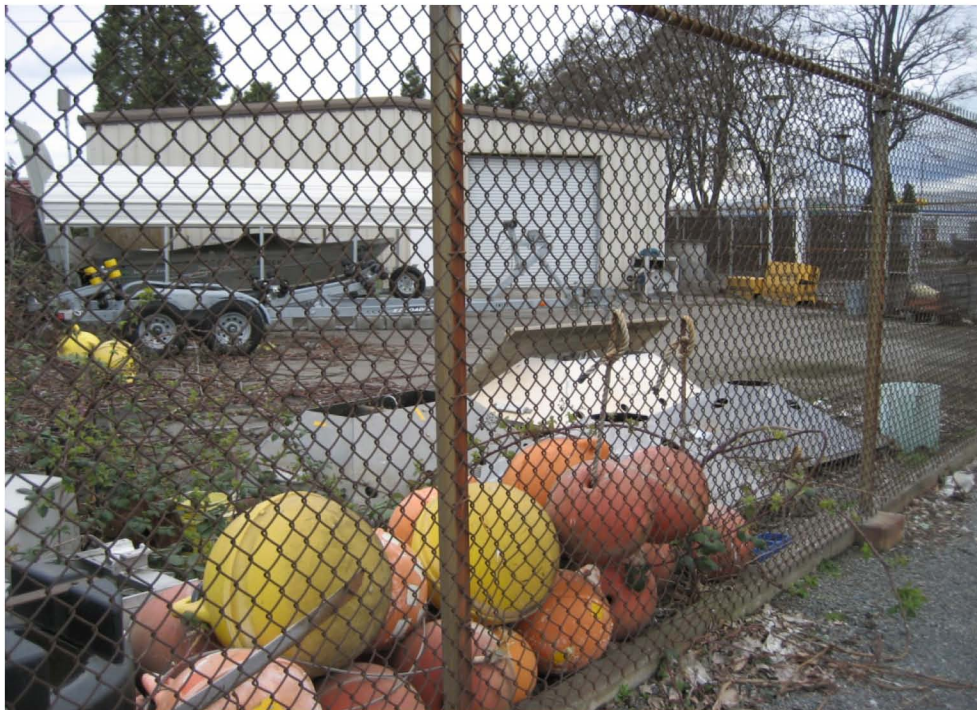
Photo 18: View (looking northeast from Diagonal Ave S) of the King County pumping station located adjacent and to the east of T-108.

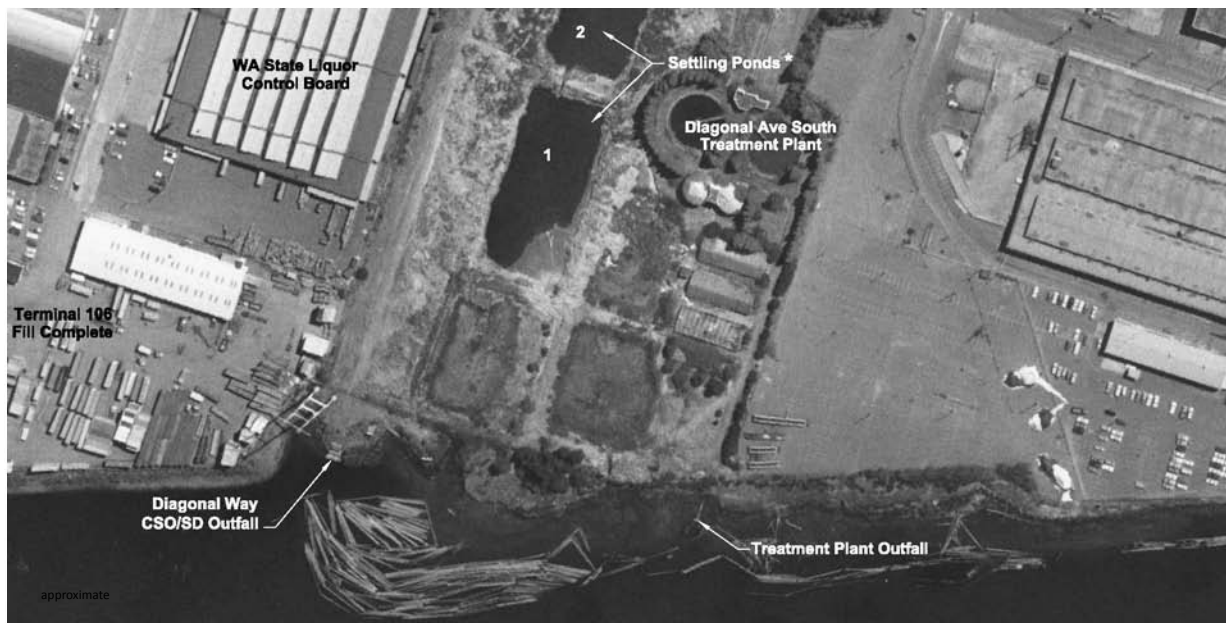
1976 aerial photograph showing settling holding pits (KCDNR et al. 2005; photograph provided by US Army Corps of Engineers, Seattle District, dated July 28, 1976)

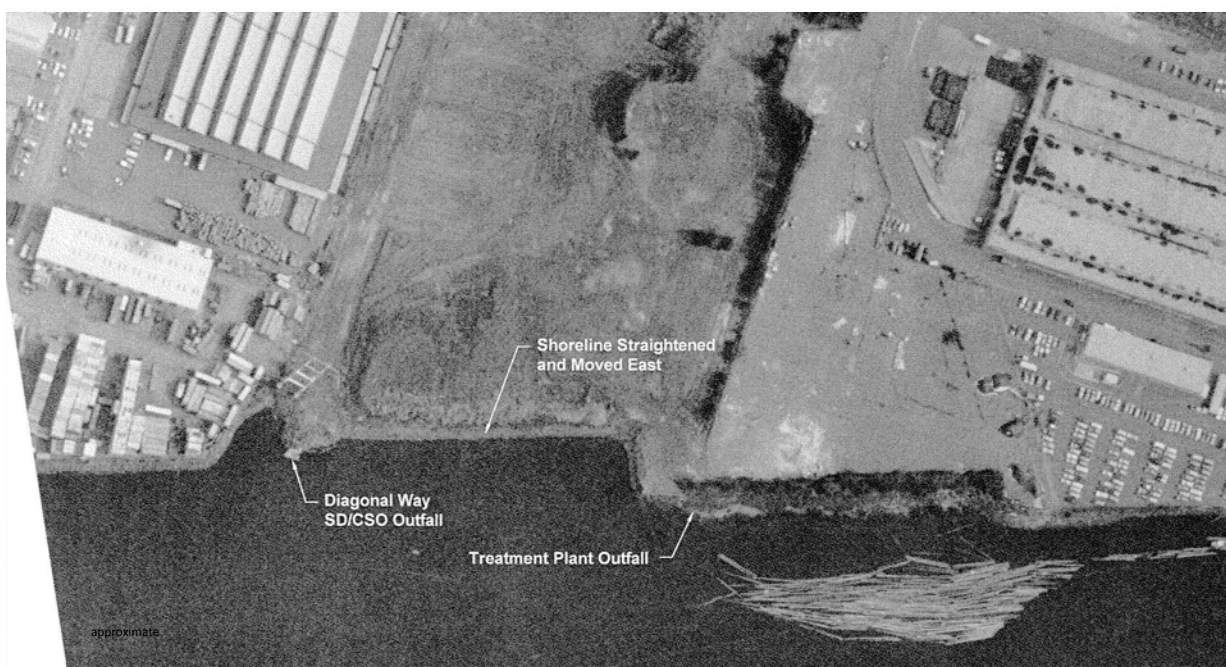
1977 aerial photograph showing settling holding pits filled (KCDNR et al. 2005; photograph provided by US Army Corps of Engineers, Seattle District, dated October 4, 1977)
